# Mechanical properties of adobe bricks in ancient constructions

Dora Silveira, Humberto Varum , Aníbal Costa, Tiago Martins, Henrique Pereira, João Almeida

A study of the mechanical properties of adobe bricks collected from houses and land dividing walls in Aveiro district, Portugal, representative of existing traditional constructions, was conducted. Cylindrical adobe specimens were subjected to simple compression and splitting tests. From these tests it was possible to evaluate the strength capacity, stiffness and deformation evolution for increasing loading. Correlations between the evaluated properties were determined, and the results obtained for houses and land dividing walls were compared. This study contributes for the characterization of adobes traditionally used in Aveiro district, and provides reference values that can be considered in rehabilitation processes.

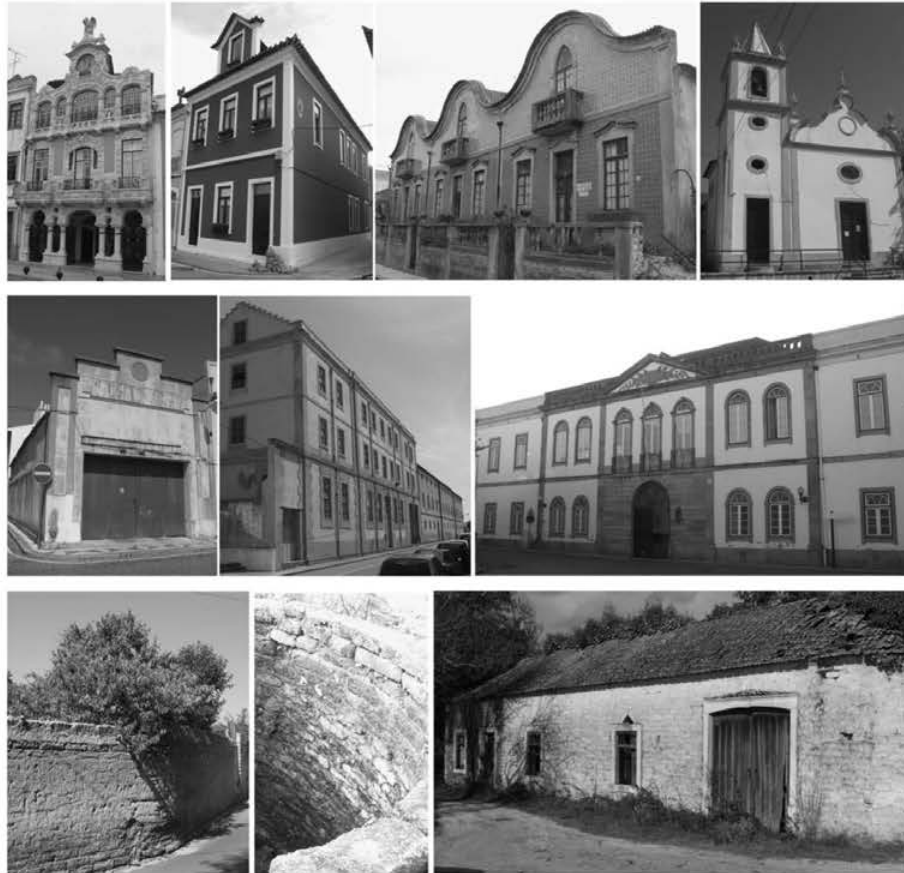
Fig. 1. Examples of existing adobe constructions in Aveiro district.

In the past, earth was also a very common construction material in Portugal. Adobe, in particular, was used throughout many years in almost all types of construction, in littoral center, particularly in Aveiro district [2,3]. Construction with adobe declined in the middle of the 20th century, with the development of cement industry [4]. Presently, according to information from Aveiro municipality, about 25% of the existing buildings in Aveiro city are made of adobe and, for the entire district, this percentage rises to 40%. The important expression of this building system in some areas of Aveiro district has been confirmed by surveys carried out recently [5,6]. Adobe can be found in several types of construction: rural and urban buildings, many of which are still in use, walls for the delimitation of properties, water wells, churches and warehouses (Fig. 1). Many of the urban adobe buildings present cultural, historical and architectonic recognized value, as for example the buildings of the "Art Nouveau" style.

The success of adobe construction in Aveiro district was principally a result of the characteristics of the existing available raw materials. The main applied raw materials were coarse sand, argillaceous earth and lime. The natural earth mixtures were corrected by the addition of clay or sand and it was also common the addition of fibers (straw or sisal, for example) to control cracking while adobes were drying in the sun.

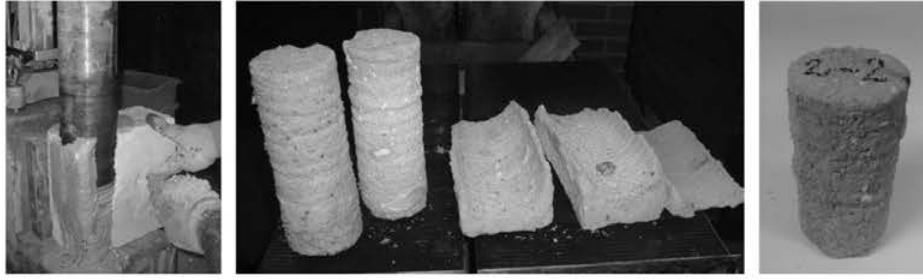
Fig. 2. Cylindrical cores extracted from the collected adobe bricks.

Cylindrical specimens were extracted from the collected adobe bricks with diameters ranging from 80 to 90 mm (Fig. 2). A few specimens were extracted with smaller diameters due to defects in the adobe bricks.

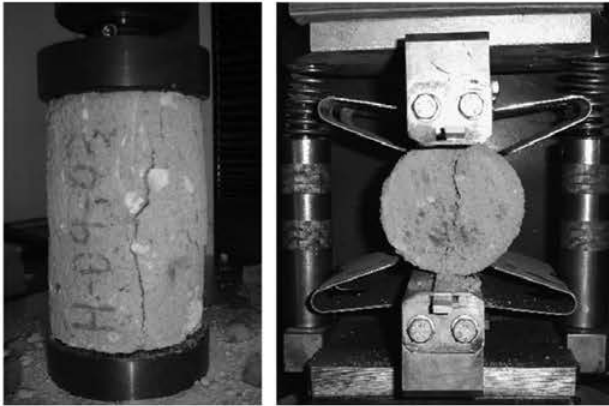
Fig. 3. Simple compression test and splitting test on adobe specimens.

A total of 101 cylindrical specimens, 51 proceeding from houses and 50 from land dividing walls, were submitted to mechanical tests, using a universal mechanical compression testing machine (Shimadzu Autograph AG 25 TA). 83 specimens were submitted to compression, and 18 to splitting tests (Fig. 3).

In the performed tests a uniform load was applied without shock and increased continuously until failure, with the moving head of the testing machine travelling at a rate of 1–2 mm/min, respecting the rate limits recommended in the Australian handbook [20].

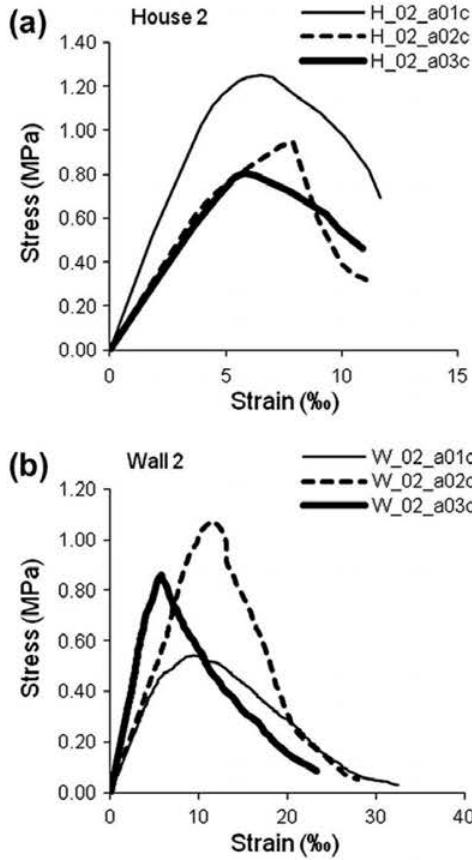
Fig. 4. Examples of stress vs. strain relations obtained in simple compression tests on adobe specimens.

Modulus of elasticity ( $E$ ) and strain at peak strength ( $\epsilon_{peak}$ ) were also estimated (Table 1) from the stress–strain behavior curves

obtained in simple compression tests (Fig. 4). It is important to note that the deformations measured correspond to the relative displacements of the testing machine platens.

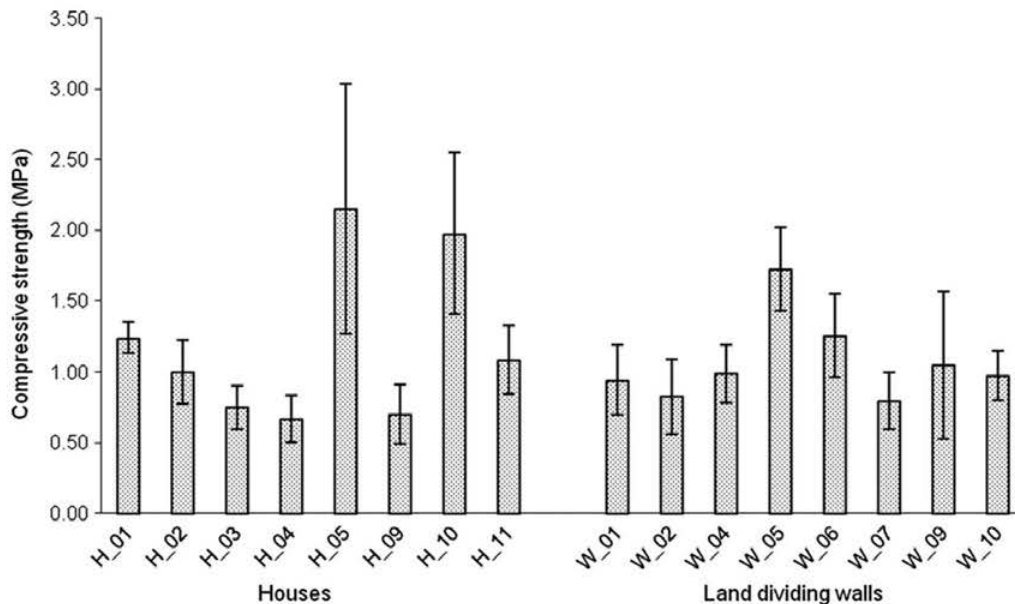
Fig. 5. Mean compressive strength of adobe specimens taken from houses (H) and land dividing walls (W), with indication of standard deviation.

The mean compressive strength, calculated per construction under analysis, ranges between 0.66 MPa (H\_04) and 2.15 MPa (H\_05) (Fig. 5). The global mean compressive strength for specimens taken from houses is 1.32 MPa, and for specimens from land dividing walls is approximately 78% of that value (1.03 MPa). The results obtained for some of the analyzed constructions present high variability, which is expressed by the standard deviations presented in Fig. 5. The variability between the mean results obtained for different constructions is also significant, and is larger (about

1.9 times) for houses, which present the lowest and highest mean compressive strength values (Fig. 5).

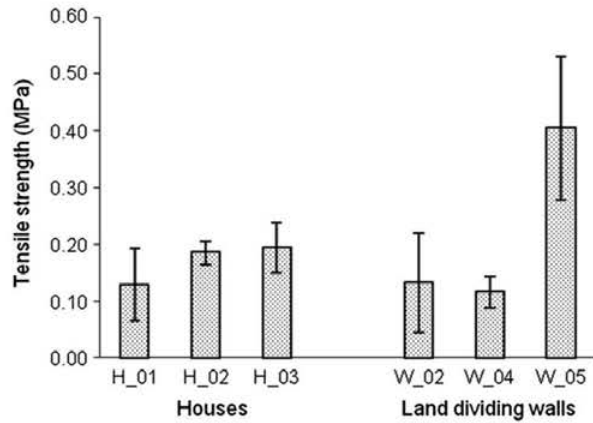
**Fig. 6.** Mean tensile strength of adobe specimens taken from houses (H) and land dividing walls (W), with indication of standard deviation.

The mean tensile strength, calculated per construction under analysis, ranges between 0.12 MPa (W\_04) and 0.40 MPa (W\_05) (Fig. 6). The global mean tensile strength for specimens taken from land dividing walls is 0.22 MPa, and for specimens from houses is approximately 78% of that value (0.17 MPa). The results obtained for some of the constructions under analysis present high variability, expressed by the standard deviations presented in Fig. 6. The variability between the mean results obtained for different constructions is also considerable.

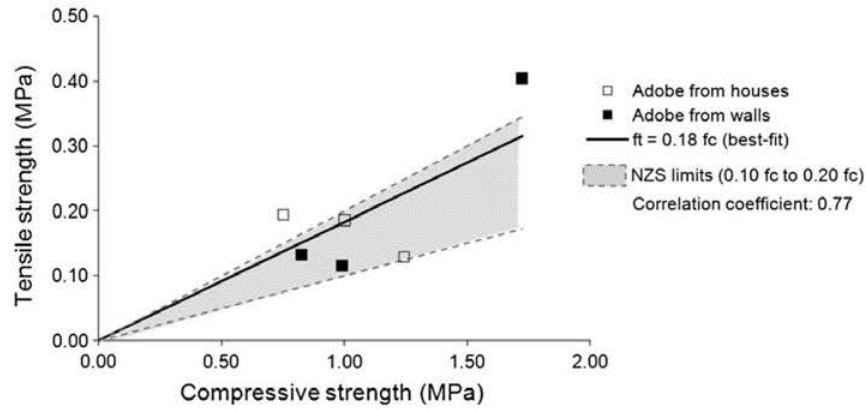
Fig. 7. Correlation between tensile and compressive strengths, with indication of the limits presented in NZS 4298:1998 [17].

The correlation between the tensile and compressive strengths of the tested specimens was studied. For each construction analyzed, the mean tensile strength was plotted against the respective mean compressive strength, and the best-fit linear correlation was determined (Fig. 7). According to this best-fit correlation, tensile strength corresponds to approximately 18% of compressive strength.

'NZS 4298:1998 Materials and workmanship for earth buildings' [17] indicates that flexural tensile strength generally lies between 10% and 20% of compressive strength, and that the majority of results lie below 30%. Thus, the correlation obtained for the studied adobe specimens from splitting tensile tests is within the limits suggested in this standard for flexural tensile strength (Fig. 7).

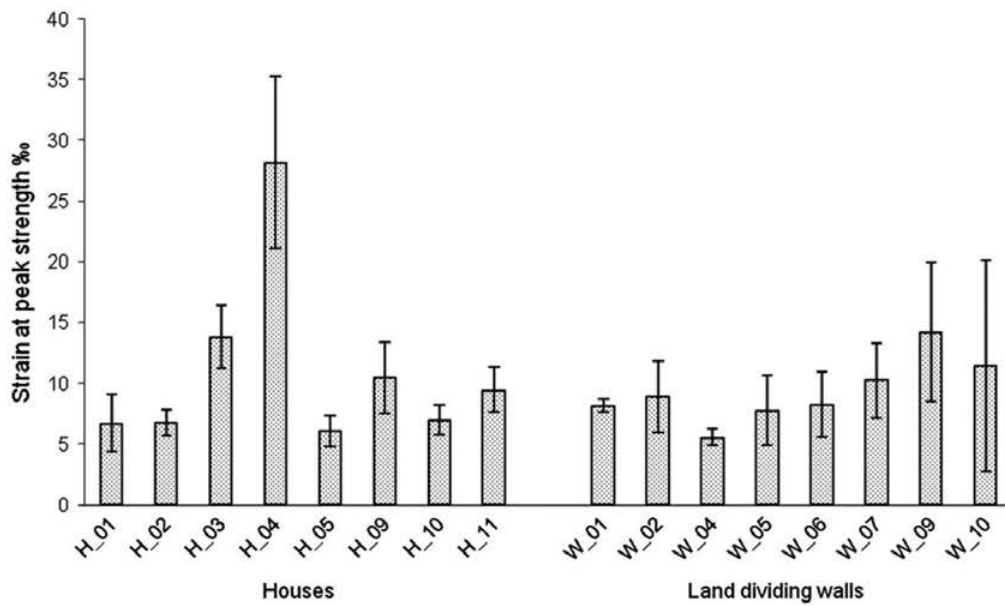
Fig. 8. Mean strain at peak strength of adobe specimens taken from houses (H) and land dividing walls (W), with indication of standard deviation.

The mean strain at peak strength, calculated per construction under analysis, ranges between 5.5‰ ( $W_{04}$ ) and 28.2‰ ( $H_{04}$ ) (Fig. 8). The global mean strain at peak strength for specimens taken from land dividing walls is of 10.3‰, and for specimens from houses is approximately 95% of that value (9.8‰).

The results obtained for some of the analyzed constructions present high variability, which is reflected in the standard deviations presented in Fig. 8. The variability between the mean results obtained for different constructions is also significant, and is larger (about 2.8 times) for houses, with house  $H_{04}$  standing out with a mean strain value much larger than the obtained for other constructions (Fig. 8).

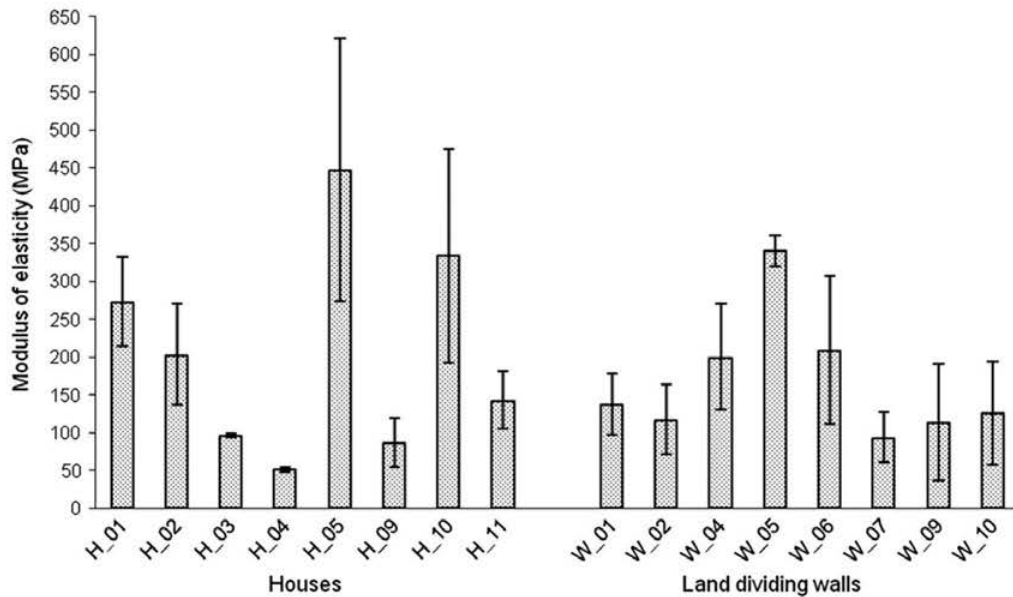
Fig. 9. Mean modulus of elasticity of adobe specimens taken from houses (H) and land dividing walls (W), with indication of standard deviation.

The mean modulus of elasticity, calculated per construction under analysis, ranges between 51 MPa ( $H_{04}$ ) and 448 MPa ( $H_{05}$ )

(Fig. 9). The global mean modulus of elasticity for specimens taken from houses is of 225 MPa, and for specimens from land dividing walls is approximately 65% of that value (147 MPa).

The results obtained for many of the analyzed constructions present high variability, expressed by the standard deviations presented in Fig. 9. The variability between the mean results obtained for different constructions is also important, and is larger (about 1.7 times) for houses, which present the lowest and highest mean modulus of elasticity values (Fig. 9).

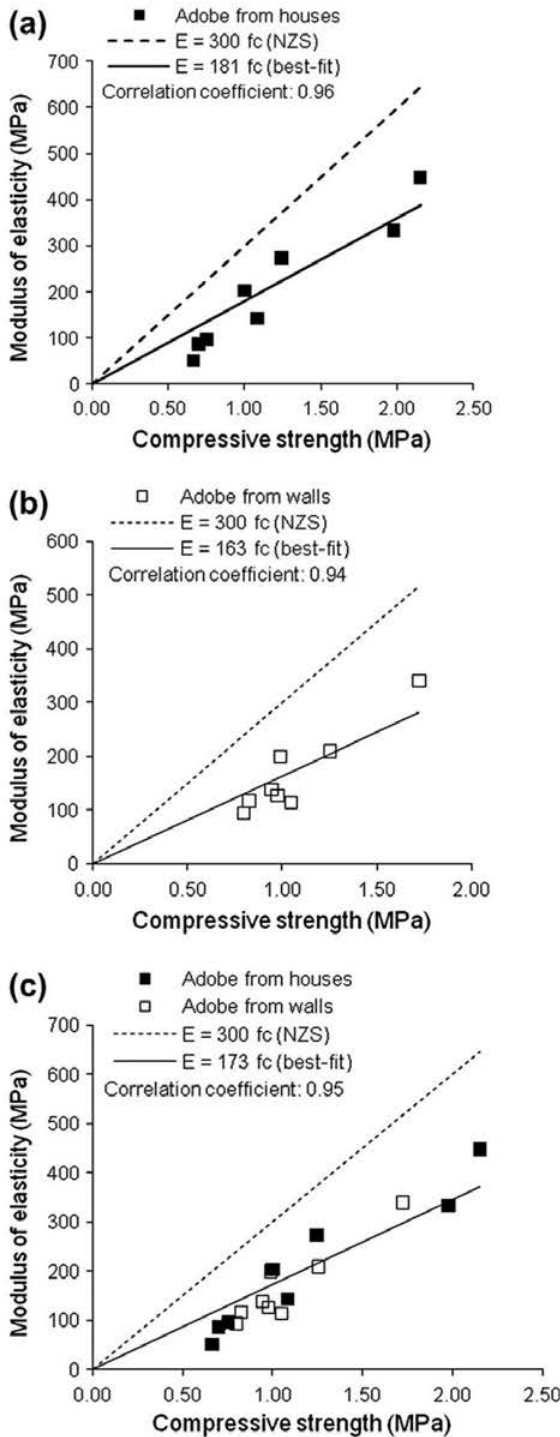
Fig. 10. Correlations between modulus of elasticity and compressive strength, for houses, land dividing walls, and all constructions.

The correlation between the modulus of elasticity and compressive strength of the tested specimens was studied. For each construction analyzed, the mean modulus of elasticity was plotted against the respective mean compressive strength (Fig. 10). A linear correlation is evident and, to represent it, 3 best-fit lines were determined (Fig. 10) – considering the mechanical results from houses, from land dividing walls, and all results together. The following correlations were obtained:  $E = 181 f_c$ , for houses;  $E = 163 f_c$ , for land dividing walls; and  $E = 173 f_c$ , for all constructions. 'NZS 4297:1998 Engineering design of earth buildings' [16] proposes a correlation of  $E = 300 f_c$  for adobe masonry walls, which is also presented in Fig. 10.

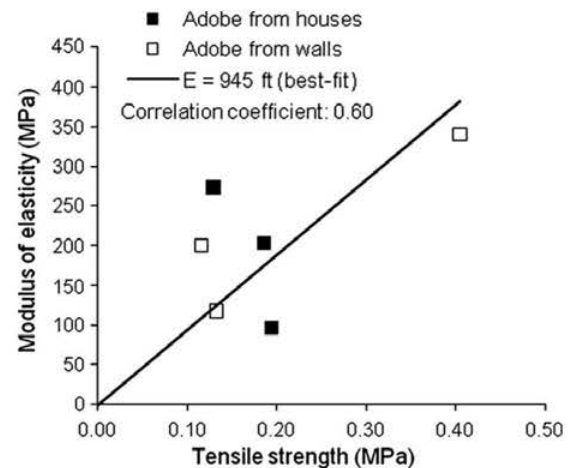
Fig. 11. Correlation between modulus of elasticity and tensile strength.

The correlation between the modulus of elasticity and tensile strength of the tested specimens was also studied, considering all the results (from houses and land dividing walls) as there are fewer results for tensile strength. For each construction analyzed, the mean modulus of elasticity was plotted against the respective mean tensile strength, and the following best-fit linear correlation was determined:  $E = 945 f_t$  (Fig. 11).
